# Reserve Study for the Fiscal Year 2022 Strathmore Riverside Villas Sarasota, Florida

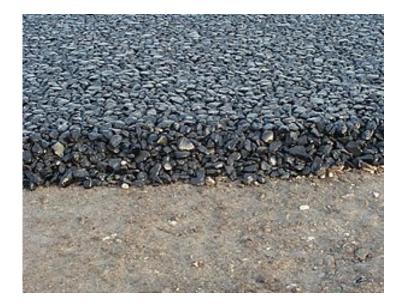
Asphalt - mill and repa	ave - 2030	35,000 SY	@ \$15.00
Asset ID	1064	Asset Actual Cost	\$525,000.00
		Percent Replacement	100%
Category	Streets/Asphalt	Future Cost	\$639,661.52
Placed in Service	January 2015	Assigned Reserves	\$187,439.25
Useful Life	15		
Replacement Year	2030	Annual Assessment	\$49,206.71
Remaining Life	8	Interest Contribution	\$354.97
		Reserve Allocation	\$49,561.68

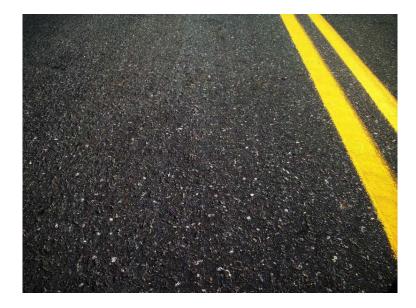
Roads and parking - S	Slurry - 2024	1 lumpsum	@ \$55,000.00
Asset ID	1063	Asset Actual Cost	\$55,000.00
		Percent Replacement	100%
Category	Streets/Asphalt	Future Cost	\$57,784.37
Placed in Service	January 2019	Assigned Reserves	\$33,000.00
Useful Life	5		
Replacement Year	2024	Annual Assessment	\$11,874.57
Remaining Life	2	Interest Contribution	\$67.31
		Reserve Allocation	\$11,941.88

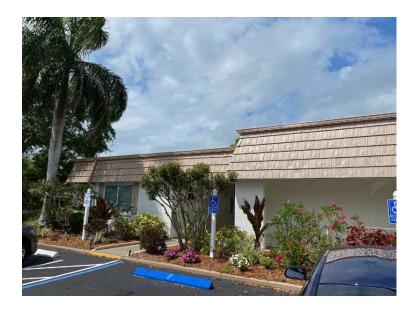
Clubhouse roof - flat se	ction - 2034	68 SQ	@ \$1,400.00
Asset ID	1010	Asset Actual Cost	\$95,200.00
		Percent Replacement	100%
Category	Roofing	Future Cost	\$128,033.42
Placed in Service	January 2014	Assigned Reserves	none
Useful Life	20		
Replacement Year	2034	Annual Assessment	\$9,123.08
Remaining Life	12	Interest Contribution	\$13.68
		Reserve Allocation	\$9,136.76

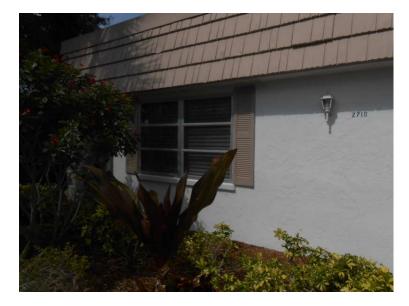
Clubhouse roof - ma	nsard section - 2030	20 SQ	@ \$850.00
Asset ID	1011	Asset Actual Cost	\$17,000.00
		Percent Replacement	100%
Category	Roofing	Future Cost	\$20,712.85
Placed in Service	January 1990	Assigned Reserves	\$13,600.00
Useful Life	40		
Replacement Year	2030	Annual Assessment	\$793.99
Remaining Life	8	Interest Contribution	\$21.59
		Reserve Allocation	\$815.59

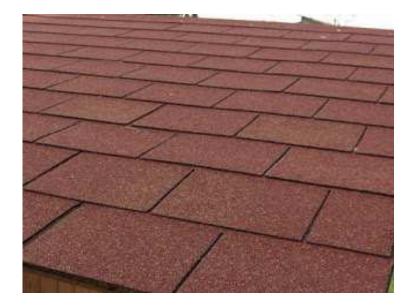
Creekhouse - Roof - 2040	J	25 SQ	@ \$490.00
Asset ID	1057	Asset Actual Cost	\$12,250.00
		Percent Replacement	100%
Category	Roofing	Future Cost	\$19,105.82
Placed in Service	January 2020	Assigned Reserves	none
Useful Life	20		
Replacement Year	2040	Annual Assessment	\$898.84
Remaining Life	18	Interest Contribution	<u>\$1.35</u>
		Reserve Allocation	\$900.19

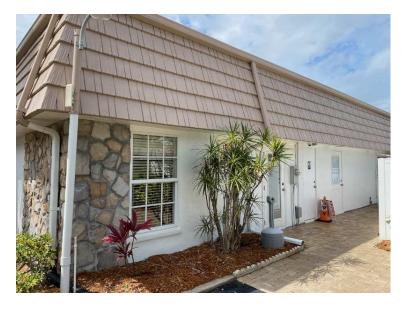
Clubhouse - exterior pa	int - 2027	1 lumpsum	@ \$8,500.00
Asset ID	1012	Asset Actual Cost Percent Replacement	\$8,500.00 100%
Category	Painting	Future Cost	\$9,616.97
Placed in Service	January 2020	Assigned Reserves	\$2,428.57
Useful Life	7		
Replacement Year	2027	Annual Assessment	\$1,271.60
Remaining Life	5	Interest Contribution Reserve Allocation	<u>\$5.55</u> \$1,277.15

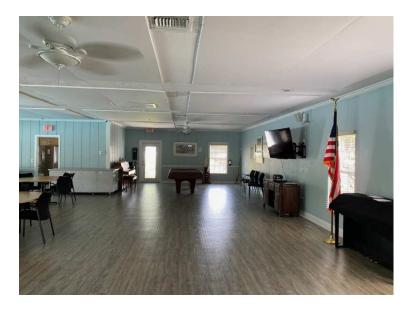
Clubhouse - interior pai	int - 2031	8,680 SF	@ \$1.00
Asset ID	1013	Asset Actual Cost Percent Replacement	\$8,680.00 100%
Category	Painting	Future Cost	\$10,840.13
Placed in Service	January 2016	Assigned Reserves	none
Useful Life	15		
Replacement Year	2031	Annual Assessment	\$1,037.53
Remaining Life	9	Interest Contribution Reserve Allocation	<u>\$1.56</u> \$1,039.08

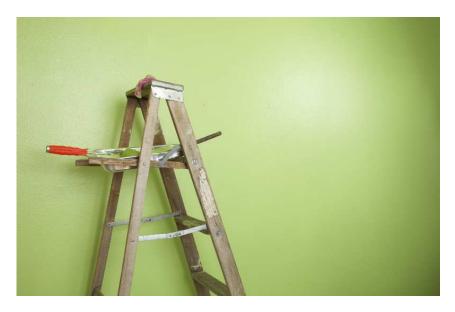
Creekhouse - Interior Pa	aint - 2023	3,000 SF	@ \$1.50
Asset ID	1054	Asset Actual Cost Percent Replacement	\$4,500.00 100%
Category	Painting	Future Cost	\$4,612.50
Placed in Service	January 2011	Assigned Reserves	\$4,125.00
Useful Life	12		
Replacement Year	2023	Annual Assessment	\$600.74
Remaining Life	1	Interest Contribution Reserve Allocation	<u>\$7.09</u> \$607.83

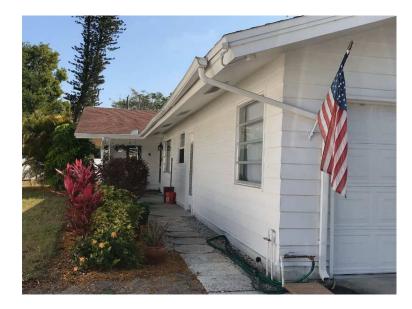
Creekhouse and Mainter	nance - Exterior Pai	nt - 2027	
		1 lumpsum	@ \$4,700.00
Asset ID	1055	Asset Actual Cost	\$4,700.00
		Percent Replacement	100%
Category	Painting	Future Cost	\$5,317.62
Placed in Service	January 2017	Assigned Reserves	\$2,350.00
Useful Life	10		
Replacement Year	2027	Annual Assessment	\$530.12
Remaining Life	5	Interest Contribution	\$4.32
		Reserve Allocation	\$534.44

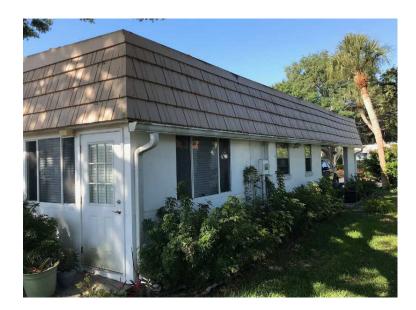
Waterproofing and Pair	nt all Villas - Tear 1 - 2	2025	
		1 lumpsum	@ \$66,538.00
Asset ID	1001	Asset Actual Cost	\$66,538.00
		Percent Replacement	100%
Category	Painting	Future Cost	\$71,654.15
Placed in Service	January 2020	Assigned Reserves	\$26,615.20
Useful Life	5		
Replacement Year	2025	Annual Assessment	\$13,709.31

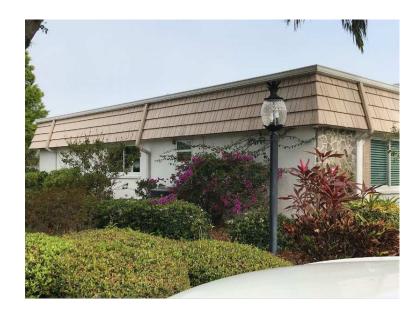
Waterproofing and Paint all Villas - Tear	2 - 2026
---	----------

1 lumpsum	@ \$67,292.00
Asset ID	1003	Asset Actual Cost	\$67,292.00
		Percent Replacement	100%
Category	Painting	Future Cost	\$74,277.78
Placed in Service	January 2021	Assigned Reserves	\$13,458.40
Useful Life	5		
Replacement Year	2026	Annual Assessment	\$13,548.05
Remaining Life	4	Interest Contribution	\$40.51
		Reserve Allocation	\$13,588.56

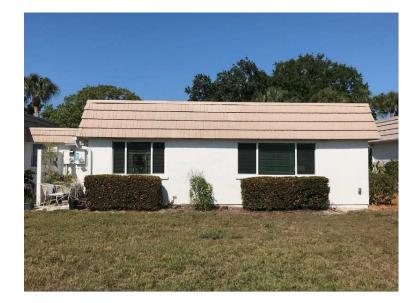
Waterproofing and Paint all Villas - Tear 3 - 2022

1 lumpsum	@ \$69,112.00
Asset ID	1004	Asset Actual Cost	\$69,112.00
		Percent Replacement	100%
Category	Painting	Future Cost	\$69,112.00
Placed in Service	January 2017	Assigned Reserves	\$69,112.00
Useful Life	5		
Replacement Year	2022	Annual Assessment	\$13,700.35
Remaining Life	0	Interest Contribution	\$20.55
		Reserve Allocation	\$13,720.90

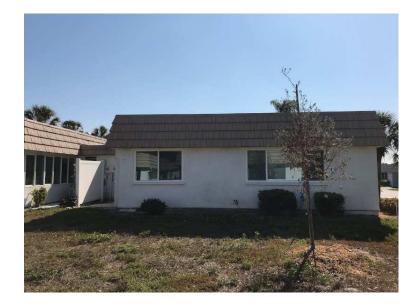
1 lumpsum	@ \$70,432.00
Asset ID	1005	Asset Actual Cost	\$70,432.00
		Percent Replacement	100%
Category	Painting	Future Cost	\$72,192.80
Placed in Service	January 2018	Assigned Reserves	\$56,345.60
Useful Life	5		
Replacement Year	2023	Annual Assessment	\$17,380.21
Remaining Life	1	Interest Contribution	<u>\$110.59</u>
		Reserve Allocation	\$17,490.80

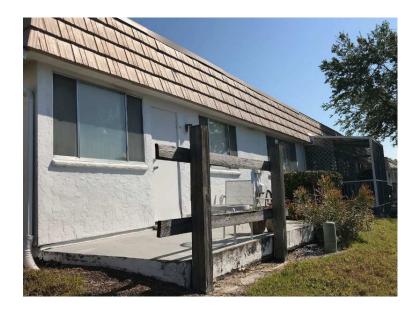
Waterproofing and Pa	aint all Villas - Tear	5 - 2024	
		1 lumpsum	@ \$71,820.00
Asset ID	1006	Asset Actual Cost	\$71,820.00
		Percent Replacement	100%
Category	Painting	Future Cost	\$75 <i>,</i> 455.89
Placed in Service	January 2019	Assigned Reserves	\$43,092.00
Useful Life	5		
Replacement Year	2024	Annual Assessment	\$15,506.03
Remaining Life	2	Interest Contribution	<u>\$87.90</u>
		Reserve Allocation	\$15,593.92

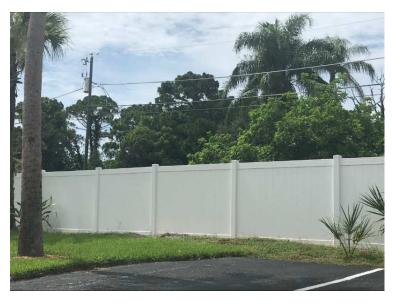
PVC Fence - 2053		5,066 L.F.	@ \$25.00
Asset ID	1024	Asset Actual Cost Percent Replacement	\$126,650.00 100%
Category	Fencing/Security	Future Cost	\$272,298.35
Placed in Service	January 2018	Assigned Reserves	none
Useful Life	35		
Replacement Year	2053	Annual Assessment	\$7,333.49
Remaining Life	31	Interest Contribution Reserve Allocation	<u>\$11.00</u> \$7,344.49

Existing fence was straightened and new fence was added. Date in service for the entire fence set at 2018. The linear feet is a combination of aerial measurements and review of the invoices.

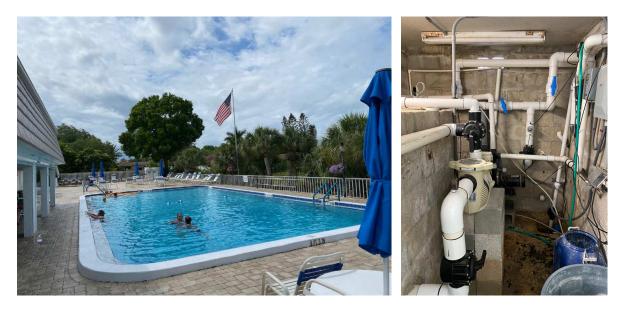
Pool - Structural Res	erve and Pumphouse - 202	3	
		1 lumpsum	@ \$50,000.00
Asset ID	1067	Asset Actual Cost	\$50,000.00
		Percent Replacement	100%
Category	Recreation/Pool	Future Cost	\$51,250.00
Placed in Service	January 2013	Assigned Reserves	\$45,000.00
Useful Life	10		
Replacement Year	2023	Annual Assessment	\$7,483.92
Remaining Life	1	Interest Contribution	<u>\$78.73</u>
		<b>Reserve Allocation</b>	\$7,562.65

Structural reserve for repairs of concrete shell and masonry structure of pool pump building.-

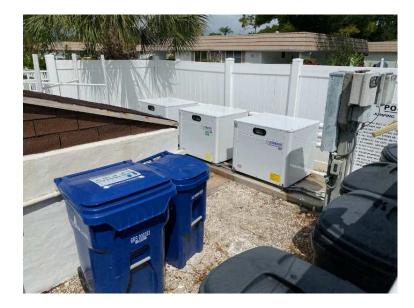
Pool - S	ymbiont Heater System	(1	) - 2036
1001 3	ymbioni neuter bystem	1 -	, 2030

1 each	@ \$9,000.00
Asset ID	1071	Asset Actual Cost	\$9,000.00
		Percent Replacement	100%
Category	Recreation/Pool	Future Cost	\$12,716.76
Placed in Service	January 2021	Assigned Reserves	none
Useful Life	15		
Replacement Year	2036	Annual Assessment	\$773.81
Remaining Life	14	Interest Contribution	\$1.16
		Reserve Allocation	\$774.97

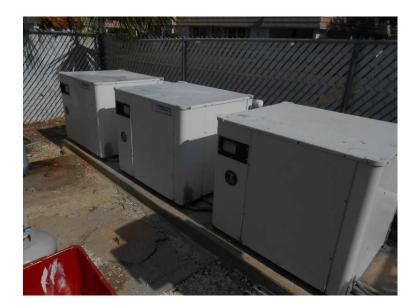
Pool - Symbiont Heater System (2) - 2031	Pool - S	vmbiont	Heater S	vstem (	2	) - 2031
--	----------	---------	----------	---------	---	----------

Asset ID	1018	2 each Asset Actual Cost Percent Replacement	@ \$9,000.00 \$18,000.00 100%
Category Placed in Service Useful Life	Recreation/Pool January 2016 15	Future Cost Assigned Reserves	\$22,479.53 none
Replacement Year Remaining Life	2031 9	Annual Assessment Interest Contribution Reserve Allocation	\$2,151.55 <u>\$3.23</u> \$2,154.78

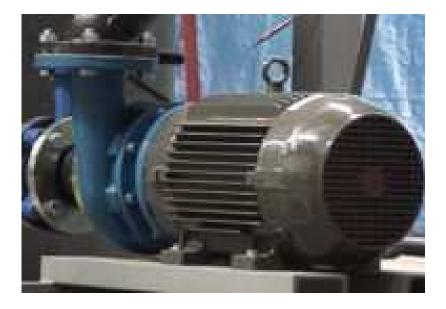
Pool - Well Pumps - 2	2022	2 each	@ \$2,500.00
Asset ID	1019	Asset Actual Cost	\$5,000.00
		Percent Replacement	100%
Category	Recreation/Pool	Future Cost	\$5,000.00
Placed in Service	January 2012	Assigned Reserves	\$5,000.00
Useful Life	10		
Replacement Year	2022	Annual Assessment	\$549.09
Remaining Life	0	Interest Contribution	\$0.82
		Reserve Allocation	\$549.91

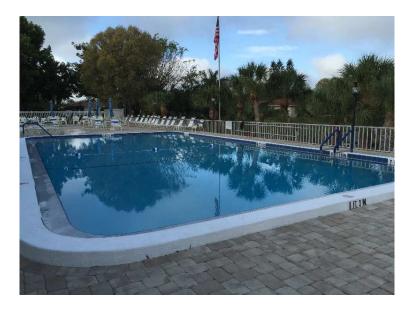
Pool - resurface - 2035	J	1,620 SF	@ \$15.00
Asset ID	1016	Asset Actual Cost	\$24,300.00
		Percent Replacement	100%
Category	Recreation/Pool	Future Cost	\$33,497.82
Placed in Service	January 2015	Assigned Reserves	none
Useful Life	20		
Replacement Year	2035	Annual Assessment	\$2,199.02
Remaining Life	13	Interest Contribution	\$3.30
		Reserve Allocation	\$2,202.32

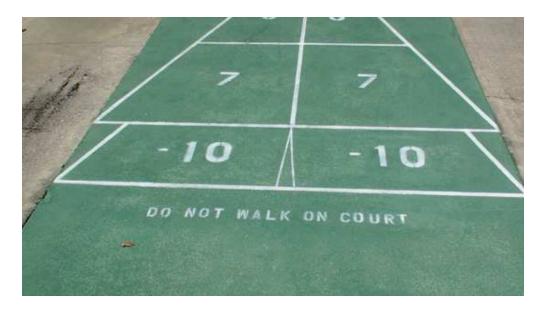
Shuffleboard Courts - 204	4	3 each	@ \$2,500.00
Asset ID	1028	Asset Actual Cost Percent Replacement	\$7,500.00 100%
Category F	Recreation/Pool	Future Cost	\$12,911.78
Placed in Service	January 2014	Assigned Reserves	none
Useful Life	30		
Replacement Year	2044	Annual Assessment	\$494.56
Remaining Life	22	Interest Contribution Reserve Allocation	<u>\$0.74</u> \$495.30

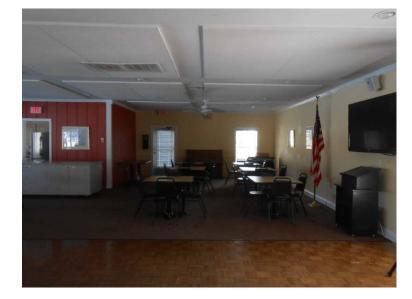
Clubhouse - general	remodel allowance - 2038		
		1 lumpsum	@ \$25,000.00
Asset ID	1014	Asset Actual Cost	\$25 <i>,</i> 000.00
		Percent Replacement	100%
Category	Interior Furnishings	Future Cost	\$37,112.64
Placed in Service	January 2018	Assigned Reserves	none
Useful Life	20		
Replacement Year	2038	Annual Assessment	\$1,969.74
Remaining Life	16	Interest Contribution	<u>\$2.95</u>
		<b>Reserve Allocation</b>	\$1,972.70

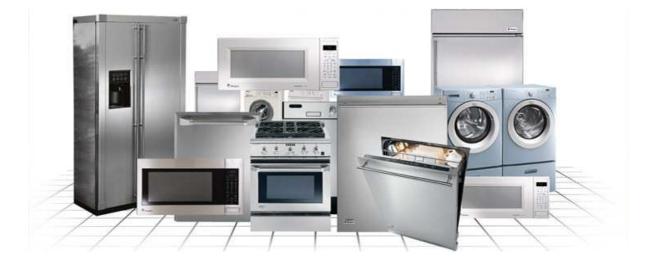
# Creekhouse - Interior Furnishings Remodel Allowance - 2033

1 lumpsum	@ \$10,000.00
Asset ID	1058	Asset Actual Cost	\$10,000.00
		Percent Replacement	100%
Category	Interior Furnishings	Future Cost	\$13,120.87
Placed in Service	January 2018	Assigned Reserves	none
Useful Life	15		
Replacement Year	2033	Annual Assessment	\$1,022.13
Remaining Life	11	Interest Contribution	\$1.53
		Reserve Allocation	\$1,023.66

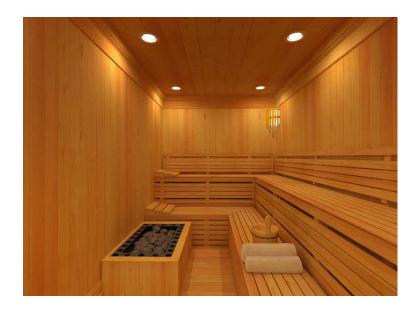
Sauna refurbish - 203	5	2 each	@ \$3,000.00
Asset ID	1034	Asset Actual Cost	\$6,000.00
		Percent Replacement	100%
Category I	Building Components	Future Cost	\$8,271.07
Placed in Service	January 2015	Assigned Reserves	none
Useful Life	20		
Replacement Year	2035	Annual Assessment	\$542.97
Remaining Life	13	Interest Contribution	\$0.81
		Reserve Allocation	\$543.78

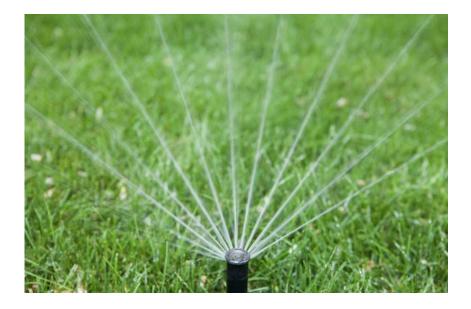
0		1 lumpsum	@ \$200,000.00
et ID	1070	Asset Actual Cost	\$200,000.00
		Percent Replacement	100%
egory (	Grounds Components	Future Cost	\$399,299.00
rvice	January 2020	Assigned Reserves	none
l Life	30		
Year	2050	Annual Assessment	\$11,940.84
g Life	28	Interest Contribution	<u>\$17.91</u>
		Reserve Allocation	\$11,958.75

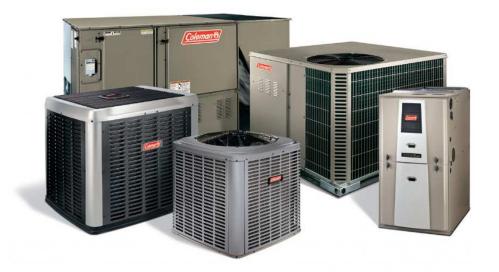
Clubhouse HVAC 3-ton	- 2028	1 each	@ \$5,500.00
Asset ID	1061	Asset Actual Cost	\$5,500.00
		Percent Replacement	100%
Category	HVAC	Future Cost	\$6,378.31
Placed in Service	January 2018	Assigned Reserves	\$2,200.00
Useful Life	10		
Replacement Year	2028	Annual Assessment	\$613.84
Remaining Life	6	Interest Contribution	\$4.22
		Reserve Allocation	\$618.06

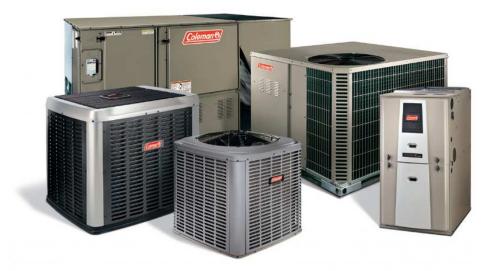
Clubhouse HVAC 5-ton - 2028		3 each	@ \$7,750.00
Asset ID	1009	Asset Actual Cost	\$23,250.00
		Percent Replacement	100%
Category	HVAC	Future Cost	\$26,962.87
Placed in Service	January 2018	Assigned Reserves	\$9,300.00
Useful Life	10		
Replacement Year	2028	Annual Assessment	\$2,594.88
Remaining Life	6	Interest Contribution	<u>\$17.84</u>
		Reserve Allocation	\$2,612.72

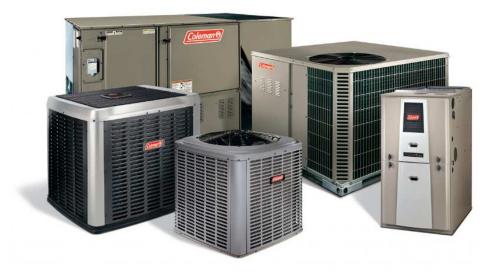
Creekhouse HVAC - 2022		1 each	@ \$5,500.00
Asset ID	1056	Asset Actual Cost	\$5,500.00
		Percent Replacement	100%
Category	HVAC	Future Cost	\$5,500.00
Placed in Service	January 2010	Assigned Reserves	\$5 <i>,</i> 500.00
Useful Life	10		
Adjustment	2	Annual Assessment	\$602.25
Replacement Year	2022	Interest Contribution	\$0.90
Remaining Life	0	Reserve Allocation	\$603.15

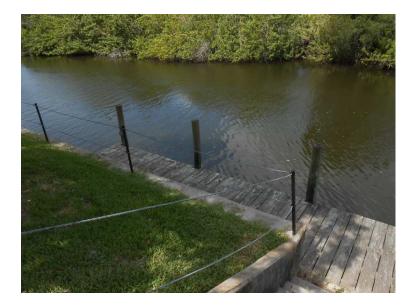
Docks along seawall - new decking - 2038		900 SF	@ \$30.00
Asset ID	1022	Asset Actual Cost Percent Replacement	\$27,000.00 100%
Category	Marina	Future Cost	\$40,081.65
Placed in Service	January 2018	Assigned Reserves	none
Useful Life	20		
Replacement Year	2038	Annual Assessment	\$2,127.32
Remaining Life	16	Interest Contribution Reserve Allocation	<u>\$3.19</u> \$2,130.51

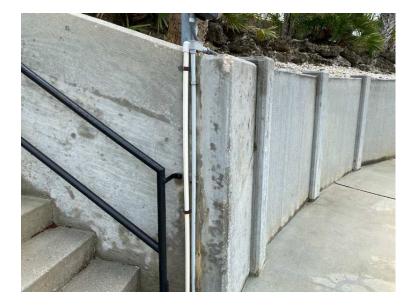
Retaining Wall - 2038		1 lumpsum	@ \$300,000.00
Asset ID	1020	Asset Actual Cost	\$300,000.00
		Percent Replacement	100%
Category	Marina	Future Cost	\$445 <i>,</i> 351.69
Placed in Service	January 2018	Assigned Reserves	none
Useful Life	20		
Replacement Year	2038	Annual Assessment	\$23,636.89
Remaining Life	16	Interest Contribution	\$35.46
		Reserve Allocation	\$23 <i>,</i> 672.35

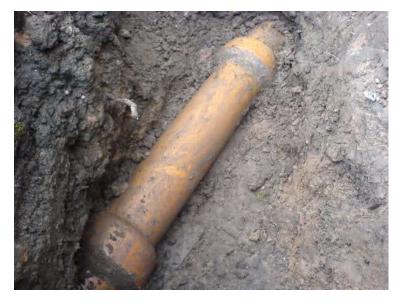
Plumbing - 2028		1 lumpsum	@ \$150,000.00
Asset I	0 1053	Asset Actual Cost	\$150,000.00
		Percent Replacement	100%
Category	y Plumbing	Future Cost	\$173,954.01
Placed in Service	e January 2018	Assigned Reserves	\$60,000.00
Useful Life	e 10		
Replacement Yea	r 2028	Annual Assessment	\$16,741.16
Remaining Life	e 6	Interest Contribution	\$115.11
		Reserve Allocation	\$16,856.27

Plumbing has a useful life which cannot really be estimated. However, it is an asset which should not be underestimated and left alone. We therefore recommend to save funds for repair/replacement of the lateral lines between buildings and main. Lumpsum of \$150,000 in ten years provides 10k each year for repairs.
